DEVELOPMENT OF A PAVEMENT MAINTENANCE MANAGEMENT SYSTEM

VOLUME II AIRFIELD PAVEMENT DISTRESS IDENTIFICATION MANUAL

**CONSTRUCTION ENGINEERING RESEARCH LABORATORY
CHAMPAIGN, ILLINOIS 61820**

DECEMBER 1977

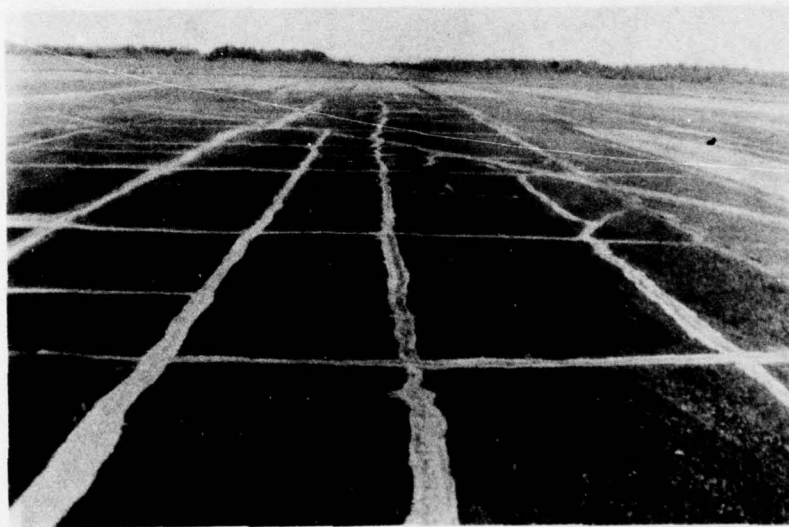
Figure 14. Low Severity Block Cracking, Filled Cracks.

- L - Blocks are defined by cracks that are nonspalled (sides of the crack are vertical) or only lightly spalled, causing no foreign object damage (FOD) potential. Nonfilled cracks have 1/4 inch or less mean width and filled cracks have a filler in satisfactory condition. (Figures 13 through 16)
- M - Blocks are defined by either (1) filled or non-filled cracks that are moderately spalled (some FOD potential); (2) nonfilled cracks that are not spalled or have only minor spalling (some FOD potential), but have a mean width greater than approximately 1/4 inch; or (3) filled cracks that are not spalled or have only minor spalling (some FOD potential), but have filler in unsatisfactory condition. (Figures 17, 18)
- H - Blocks are well-defined by cracks that are severely spalled, causing a definite FOD potential. (Figures 19, 20, 21)

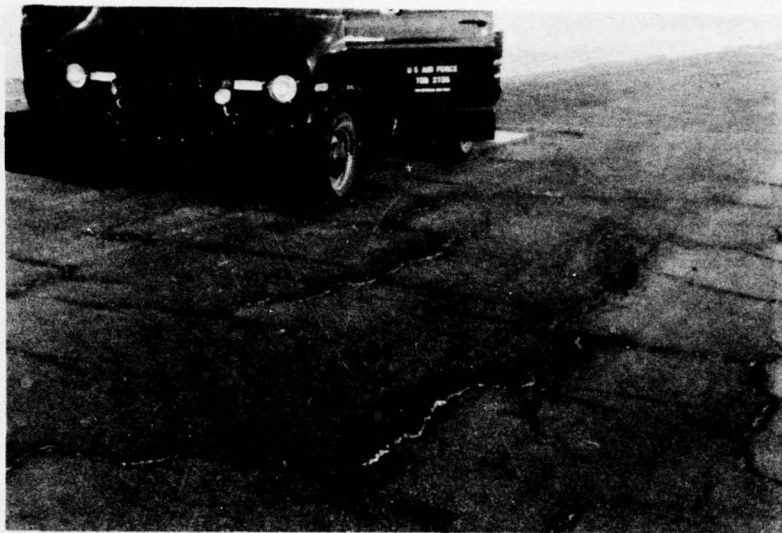
Figure 19. High Severity Block Cracking.

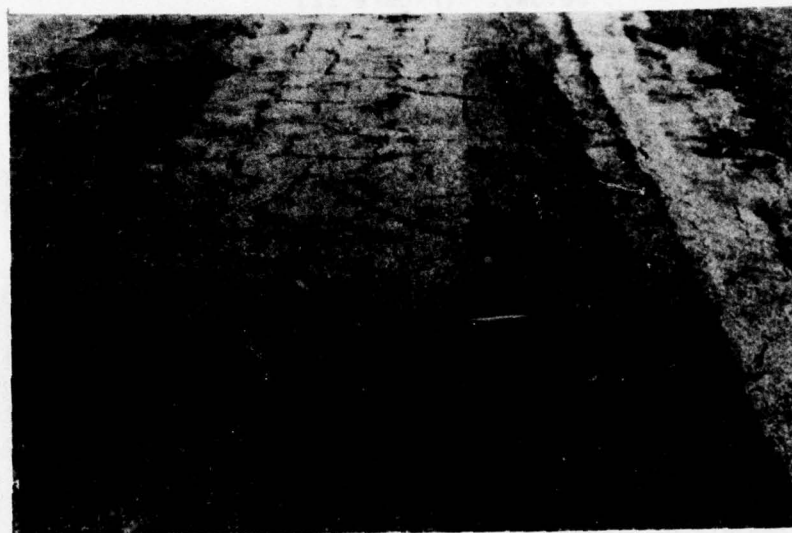
Figure 21. High Severity Block Cracking.

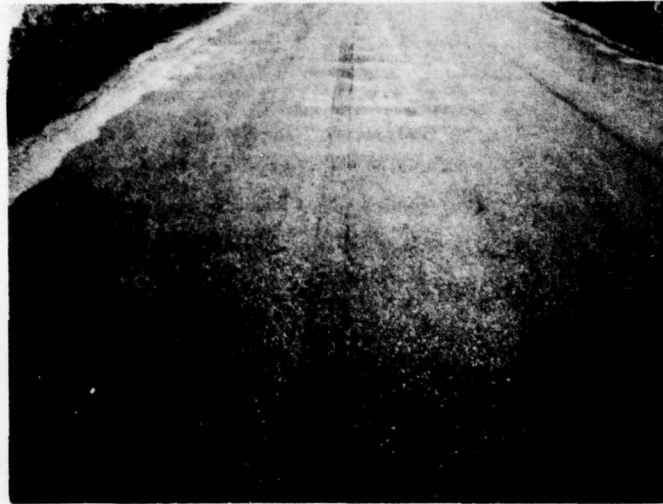
Figure 22. Low Severity Corrugation in the Foreground, Changing to Medium and High in the Background.

- L - Corrugations are minor and do not significantly affect ride quality (see measurement criteria below). (Figure 22)
- M - Corrugations are noticeable and significantly affect ride quality (see measurement criteria below.) (Figure 23)
- H - Corrugations are easily noticed and severely affect ride quality (see measurement criteria below). (Figure 24)

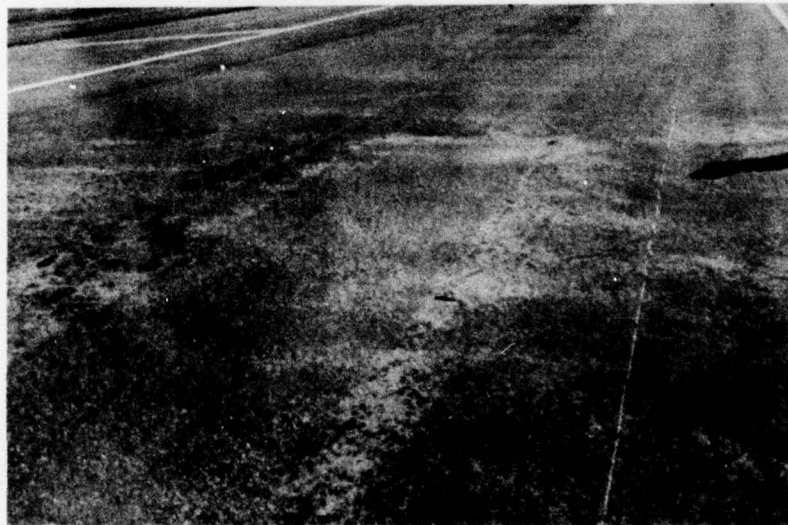
Figure 23. Medium Severity Corrugation.

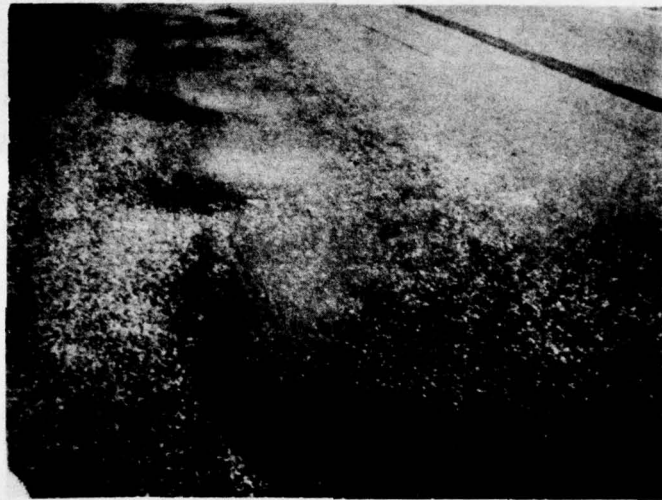
Figure 24. High Severity Corrugation.

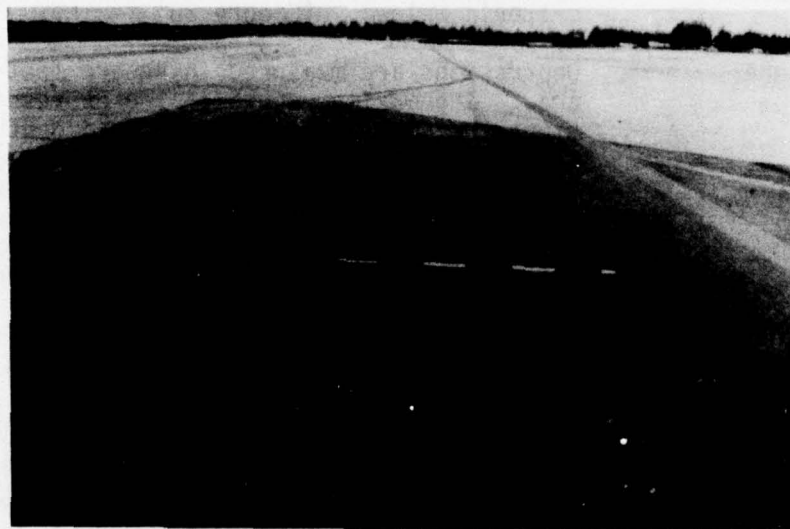
Figure 26. Medium Severity Depression ($> 1/2$ Inch).

- L - Depression can be observed or located by stained areas, only slightly affects pavement riding quality, and may cause hydroplaning potential on runways (see measurement criteria below). (Figure 25)
- M - The depression can be observed, moderately affects pavement riding quality, and causes hydroplaning potential on runways (see measurement criteria below). (Figures 26, 27)
- H - The depression can be readily observed, severely affects pavement riding quality, and causes definite hydroplaning potential (see measurement criteria below). (Figure 28)

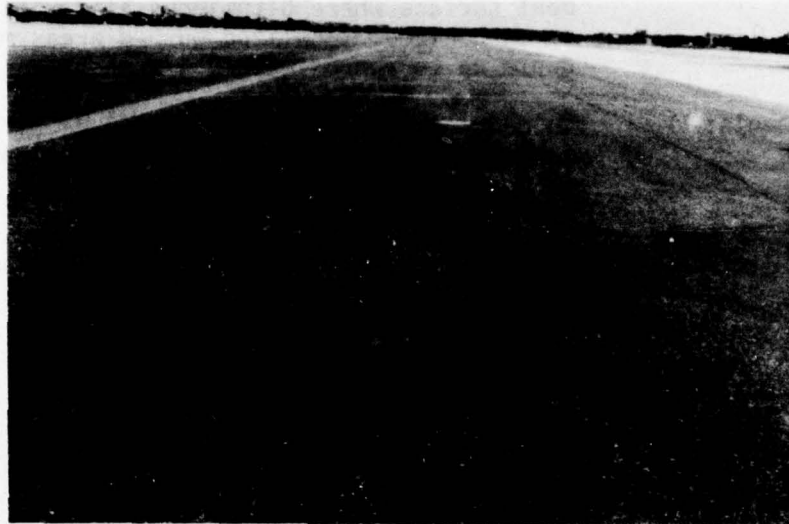
Figure 27. Medium Severity Depression ($> 1/2$ Inch).

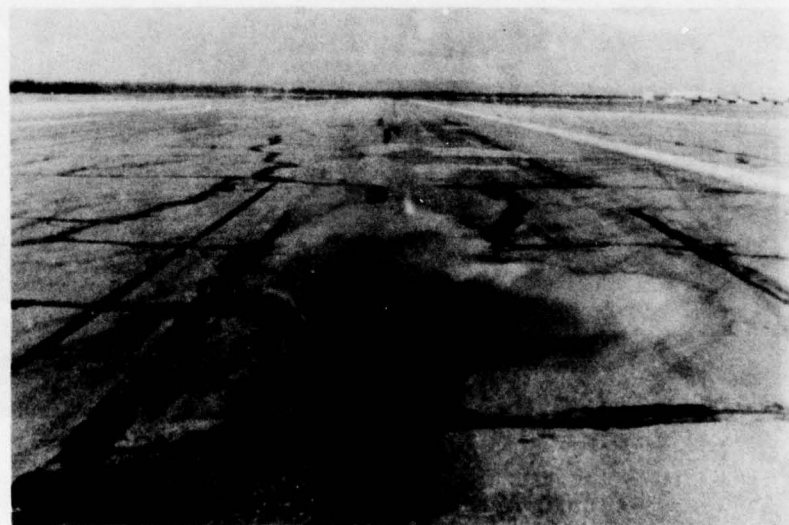
Figure 28. High Severity Depression (2 Inches).

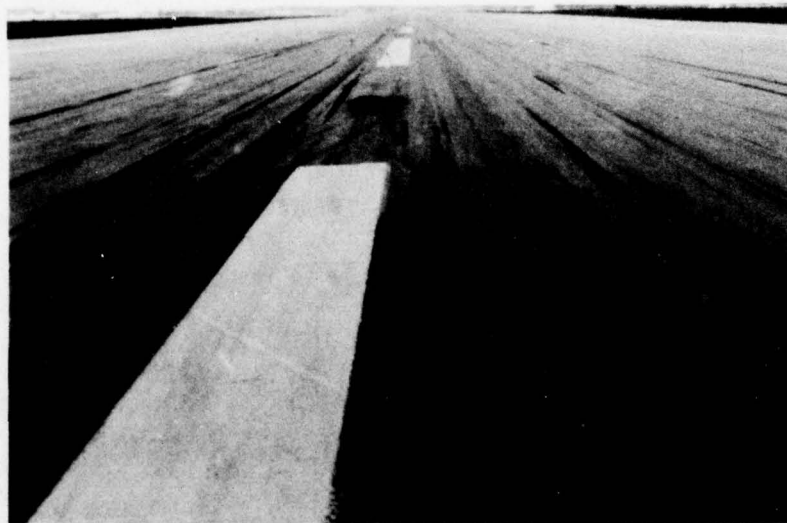
Figure 29. Jet Blast Erosion.

Name of Distress:	Jet Blast Erosion
Description:	Jet blast erosion causes darkened areas on the pavement surface where bituminous binder has been burned or carbonized; localized burned areas may vary in depth up to approximately 1/2 inch.
Severity Levels:	No degrees of severity are defined. It is sufficient to indicate that jet blast erosion exists. (Figures 29, 30)
How to Measure:	Jet blast erosion is measured in square feet of surface area.

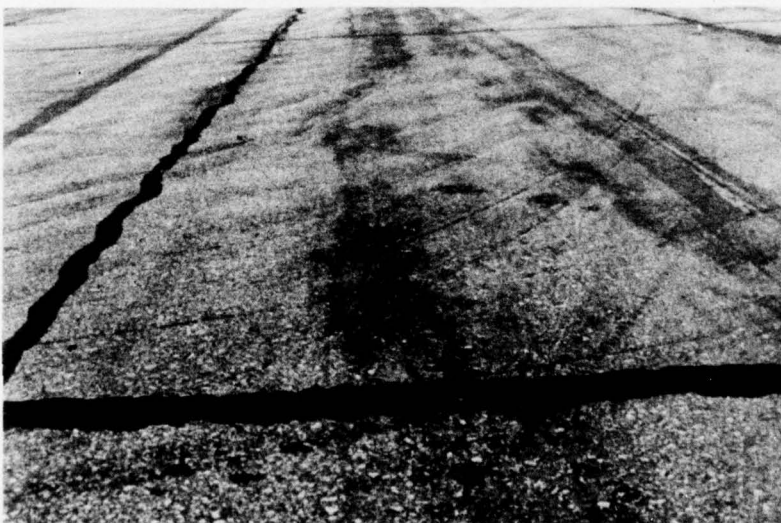
Figure 32. Low Severity Joint Reflection Cracking, Filled Crack.

- L - Cracks have only light spalling (little or no FOD potential) or no spalling, and can be filled or nonfilled. If nonfilled, the cracks have a mean width of 1/4 inch or less; filled cracks are of any width, but their filler material is in satisfactory condition. (Figures 31, 32, 33)

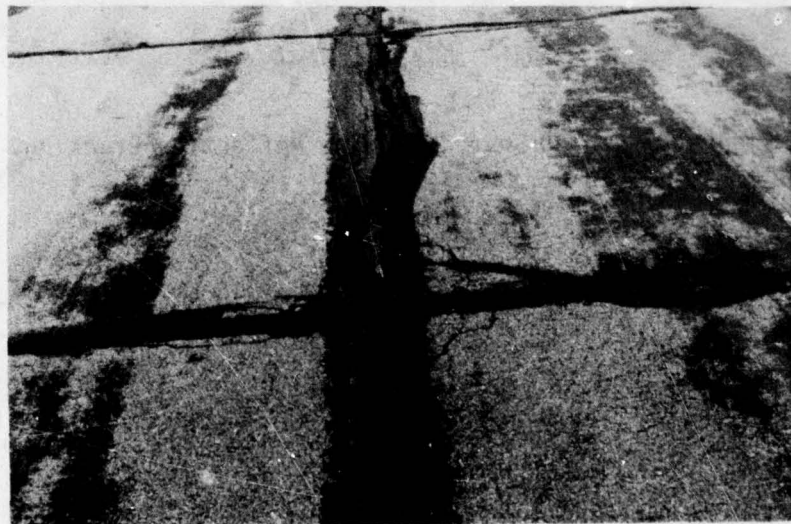
Figure 36. Medium Severity Joint Reflection Cracking.

- M - One of the following conditions exists: (1) cracks are moderately spalled (some FOD potential) and can be either filled or nonfilled of any width; (2) filled cracks are not spalled or are only lightly spalled, but the filler is in unsatisfactory condition; (3) nonfilled cracks are not spalled or are only lightly spalled, but the mean crack width is greater than 1/4 inch; or (4) light random cracking exists near the crack or at the corners of intersecting cracks. (Figures 34, 35, 36)

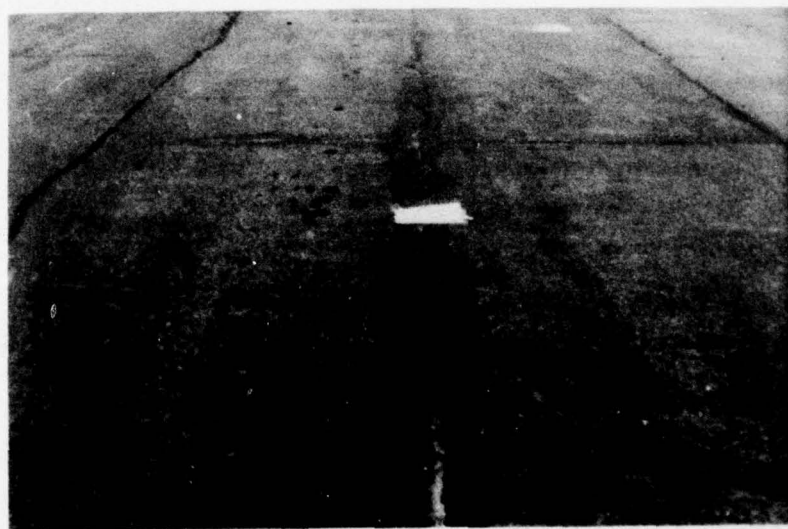
- M - One of the following conditions exists: (1) cracks are moderately spalled (some FOD potential) and can be either filled or nonfilled of any width; (2) filled cracks are not spalled or are only lightly spalled, but the filler is in unsatisfactory condition; (3) nonfilled cracks are not spalled or are only lightly spalled, but mean crack width is greater than 1/4 inch; or (4) light random cracking exists near the crack or at the corners of intersecting cracks. (Figures 40, 41, 42)

Figure 41. Medium Severity Longitudinal Crack. (Note the Crack Is Reflective But Not at the Joint of Slab.)

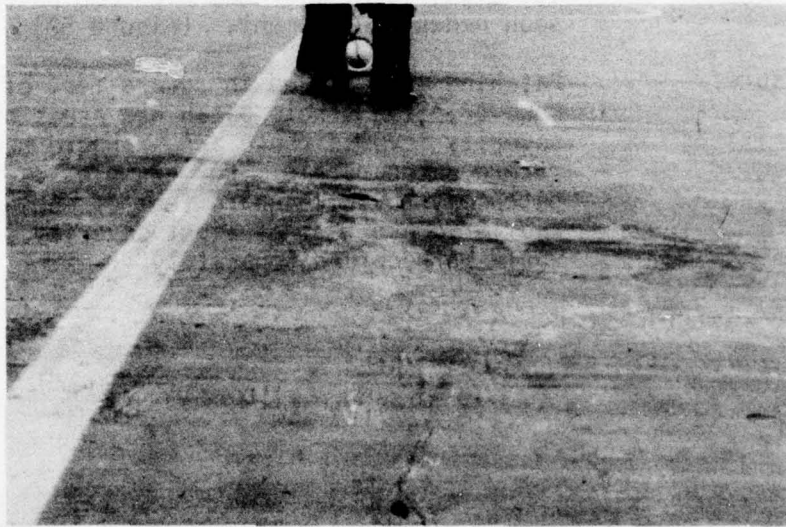
Description: Oil spillage is the deterioration or softening of the pavement surface caused by the spilling of oil, fuel, or other solvents. (Figures 44, 45)

Figure 44. Oil Spillage.

Figure 45. Oil Spillage.

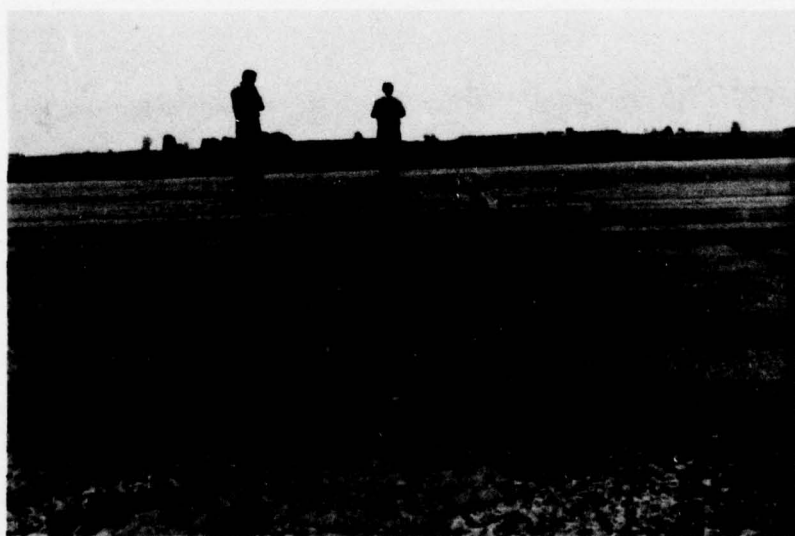
Figure 50. High Severity Patch.

H - Patch is badly deteriorated and affects ride quality significantly or has high FOD potential. Patch soon needs replacement. (Figure 50)

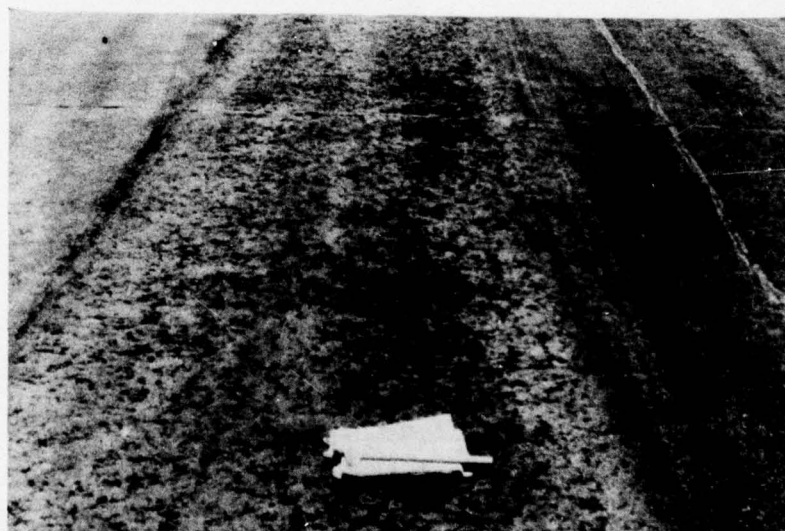
Figure 54. Light Severity Raveling/Weathering, Approaching Medium Severity.

- L - Aggregate or binder has started to wear away, causing little or no FOD potential. (Figures 52, 53, 54)
- M - Aggregate and/or binder has worn away, causing some FOD potential. The surface texture is moderately rough and pitted. (Figure 55)
- H - Aggregate and/or binder has worn away, causing a high FOD potential. The surface texture is severely rough and pitted. (Figures 56, 57)

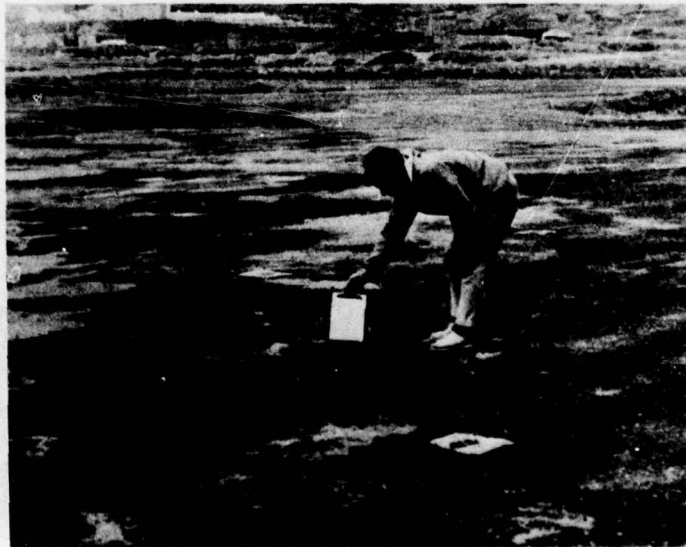
Figure 56. High Severity Raveling/Weathering.

Figure 57. High Severity Raveling/Weathering.

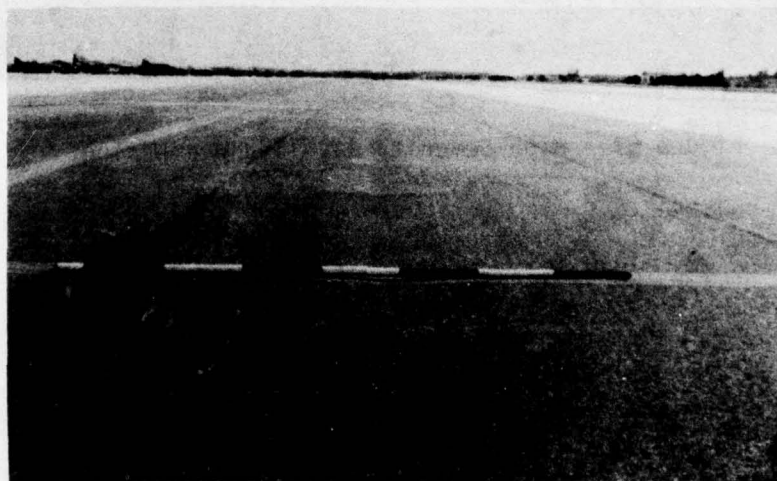
Severity	All Pavement Sections
L	1/4 - 1/2 inch (Figures 58, 59)
M	>1/2 - 1 inch (Figure 60)
H	>1 inch (Figures 61, 62)

Figure 58. Light Severity Rutting.

Figure 59. Light Severity Rutting.

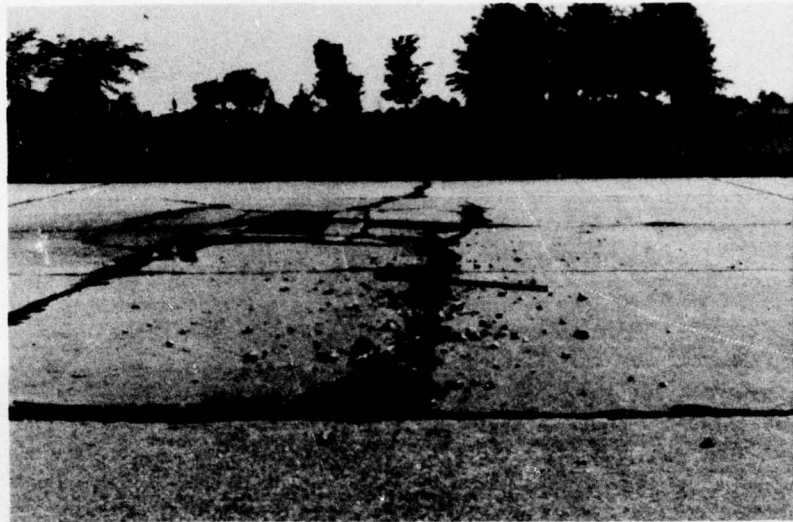
- L - Buckling or shattering has not rendered the pavement inoperative, and only a slight amount of roughness exists. (Figure 71)
- M - Buckling or shattering has not rendered the pavement inoperative, but a significant amount of roughness exists. (Figure 72)
- H - Buckling or shattering has rendered the pavement inoperative. (Figure 73)

Figure 71. Low Severity Blow-Up. (Note That This Would Only Be Considered Low Severity If the Shattering in the Foreground Was the Only Part Existing and the Foreign Material Removed.)

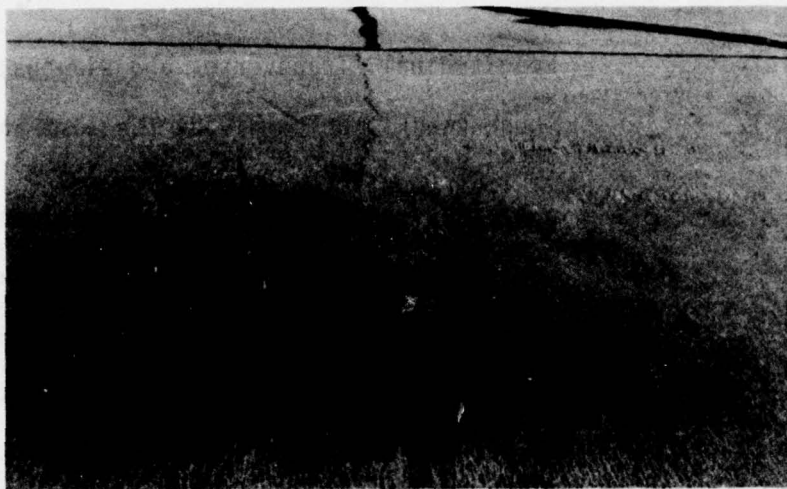
Figure 79. Low Severity Longitudinal Crack.

- L - (1) crack has no spalling or minor spalling (no FOD potential). If nonfilled, it is less than 1/8 inch wide; a filled crack can be of any width, but its filler material must be in satisfactory condition. (Figures 79, 80, 81)

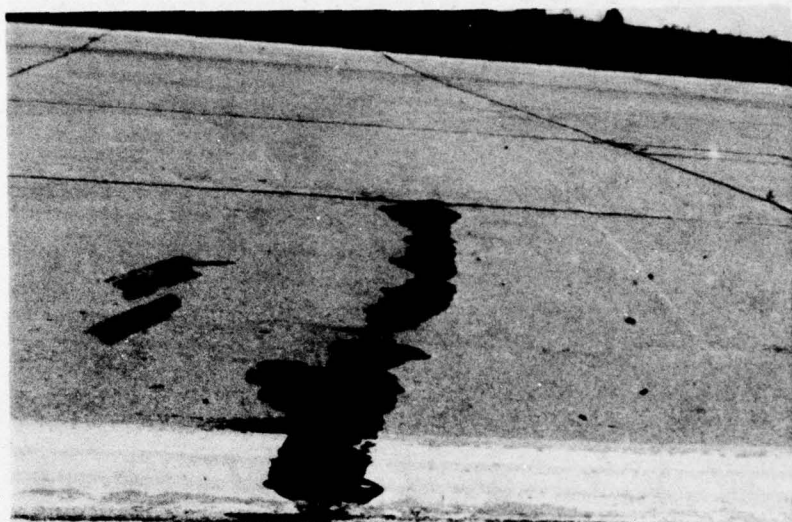
Figure 83. Medium Severity Transverse Crack.

- M - One of the following conditions exists: (1) a filled or nonfilled crack is moderately spalled (some FOD potential); (2) a nonfilled crack has a mean width between 1/8 inch and 1 inch; (3) a filled crack has no spalling or minor spalling, but the filler is in unsatisfactory condition; or (4) the slab is divided into three pieces by low severity cracks. (Figures 82, 83, 84)

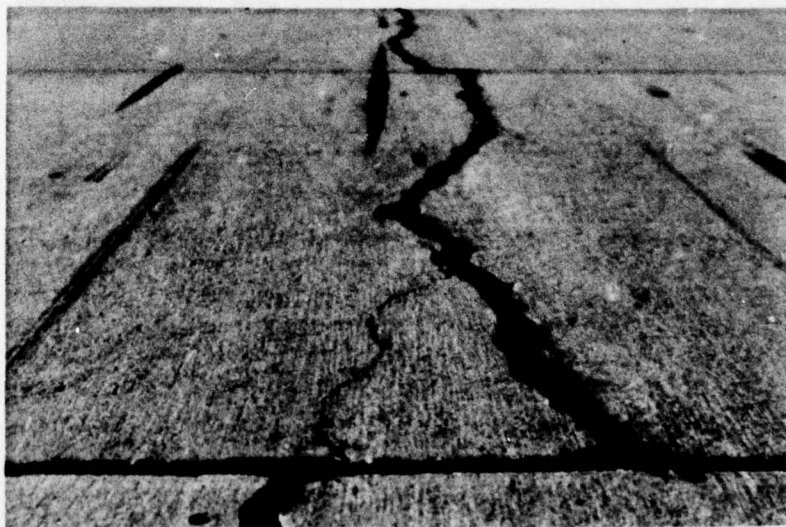
Figure 86. High Severity Longitudinal Cracks.

- H - One of the following conditions exists: (1) a filled or nonfilled crack is severely spalled (definite FOD potential); (2) a nonfilled crack has a mean width approximately greater than 1 inch, creating tire damage potential; or (3) the slab is divided into three pieces by two or more cracks, one of which is at least medium severity. (Figures 85, 86, 87)

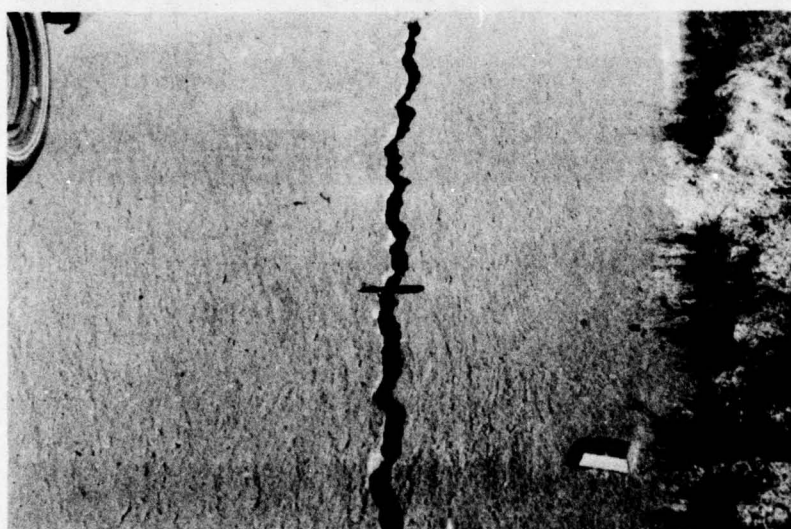
Figure 87. High Severity Crack.

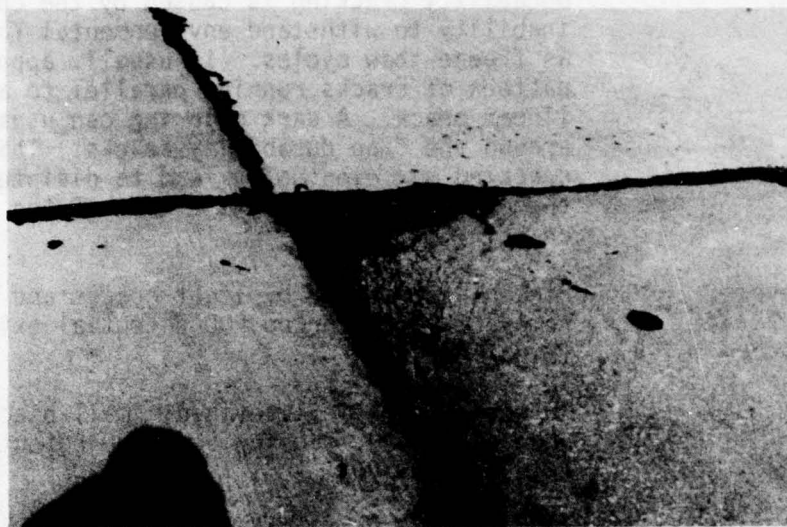
Figure 88. Low Severity "D" Cracking.

- L - Pieces are defined by light cracks and cannot be removed; little or no FOD potential exists. (Figure 88)
- M - "D" cracks are well defined; small pieces have been displaced, causing some FOD potential. (Figures 89, 90)
- H - "D" cracking has developed over a considerable amount of slab area (greater than approximately one-quarter of the slab area) and the pieces are well defined and can be removed easily. The area is a considerable source of FOD potential. (Figure 91)

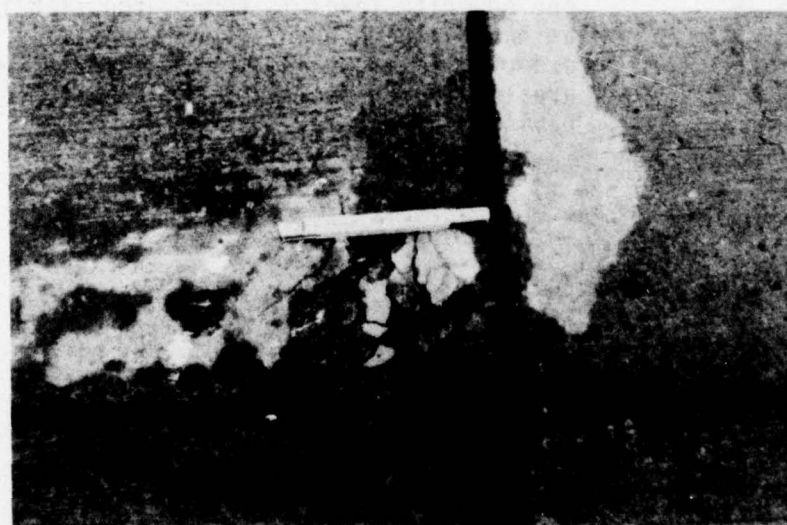
Figure 89. Medium Severity "D" Cracking.

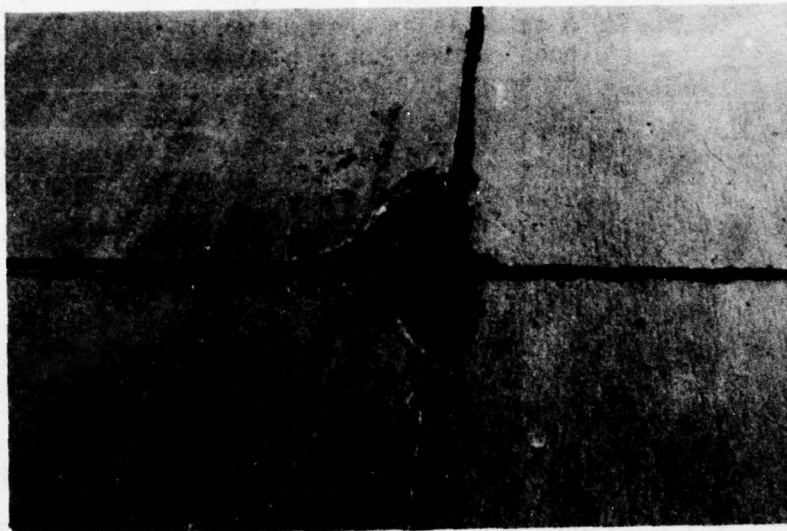
Figure 97. Low Severity Small Patch.

- Severity Levels:
- L - Patch is functioning well with little or no deterioration. (Figures 96, 97)
 - M - Patch has deteriorated, and/or moderate spalling can be seen around the edges. Patch material can be dislodged with considerable effort (minor FOD potential). (Figures 98, 99)

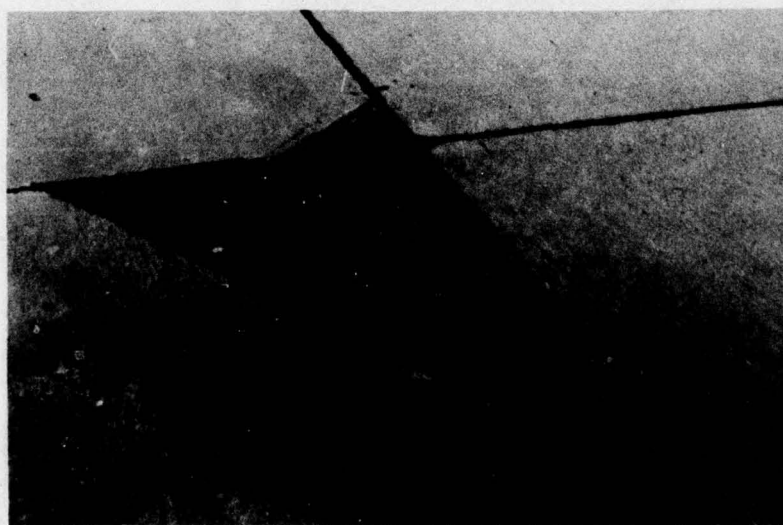
Figure 101. Low Severity Patch.

- L - Patch is functioning well with very little or no deterioration. (Figures 101, 102, 103)
- M - Patch as deteriorated and/or moderate spalling can be seen around the edges. Patch material can be dislodged with considerable effort, causing some FOD potential. (Figure 104)
- H - Patch has deteriorated to a state which causes considerable roughness and/or high FOD potential. The extent of the deterioration warrants replacement of the patch. (Figure 105)

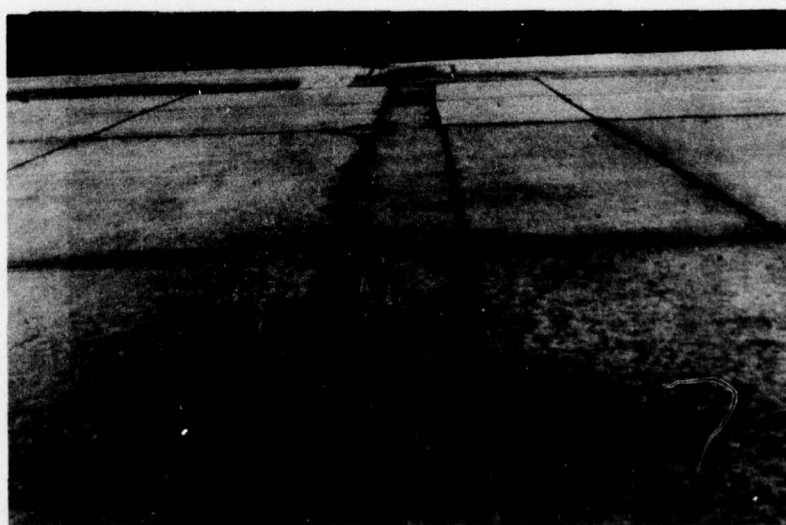
Figure 103. Low Severity Utility Cut.

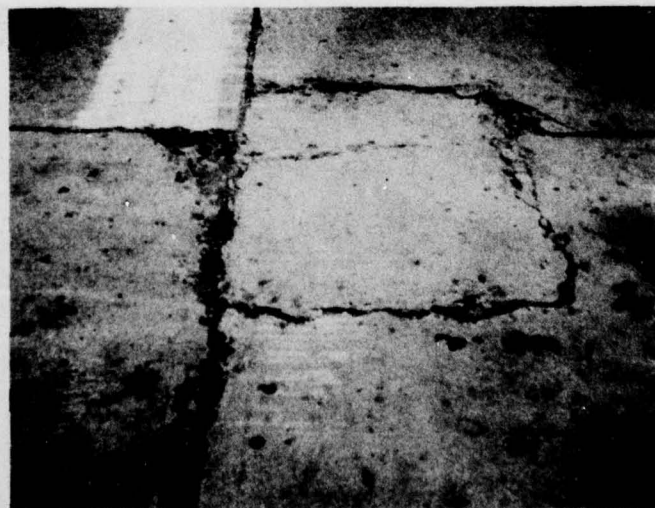
Figure 105. High Severity Patch.

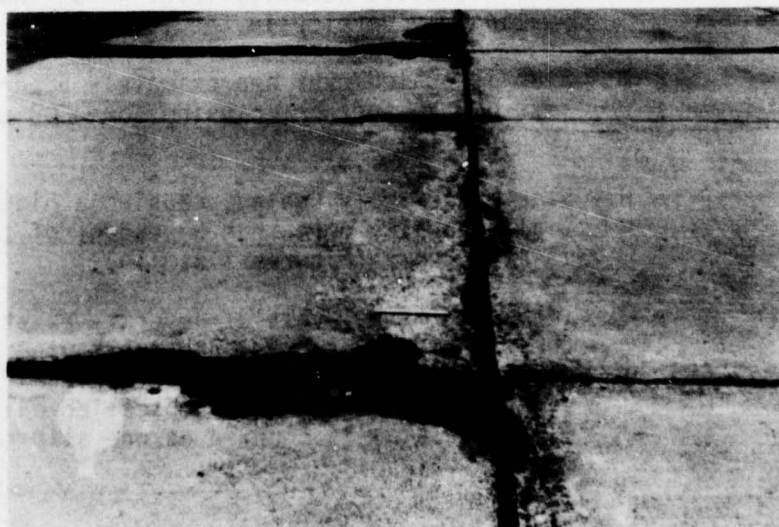
Figure 112. Medium Severity Scaling.

- M - Slab is scaled over approximately 5 percent or less of the surface, causing some FOD potential. (Figure 112)
- H - Slab is severely scaled, causing a high FOD potential. Usually more than 5 percent of the surface is affected. (Figures 113, 114)

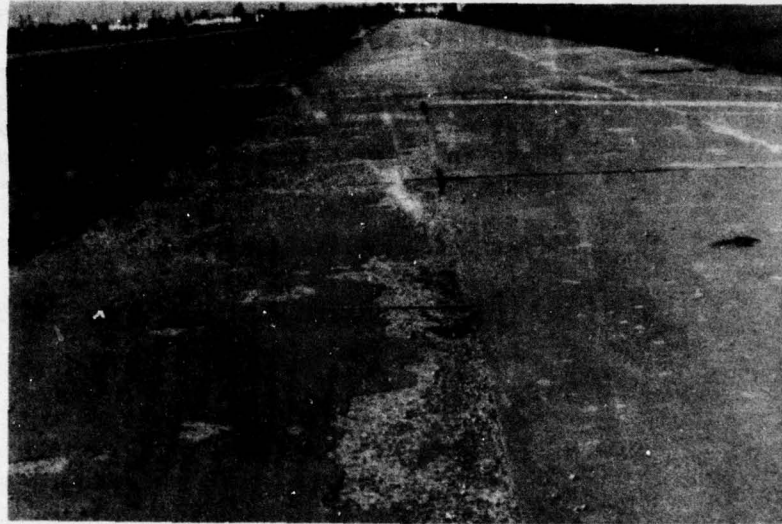
Figure 113. High Severity Scaling.

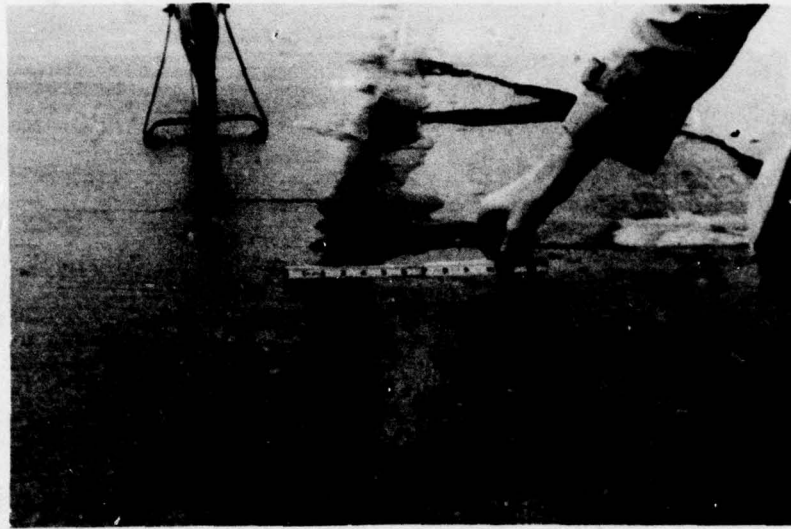
Figure 117. Medium Severity Settlement on Apron ($>1/2$ Inch).

<u>Runways/Taxiways</u>	<u>Aprons</u>
L	< 1/4 inch	1/8 inch < 1/2 inch (Figures 115, 116)
M	1/4 inch ≤ 1/2 inch	1/2 inch < 1 inch (Figure 117)
H	> 1/2 inch (Figures 118, 119)	> 1 inch

In counting settlement, a fault between two slabs is counted as one slab (see diagram). A straight-edge or level should be used to aid in measuring the difference in elevation between the two slabs (Figure 117).

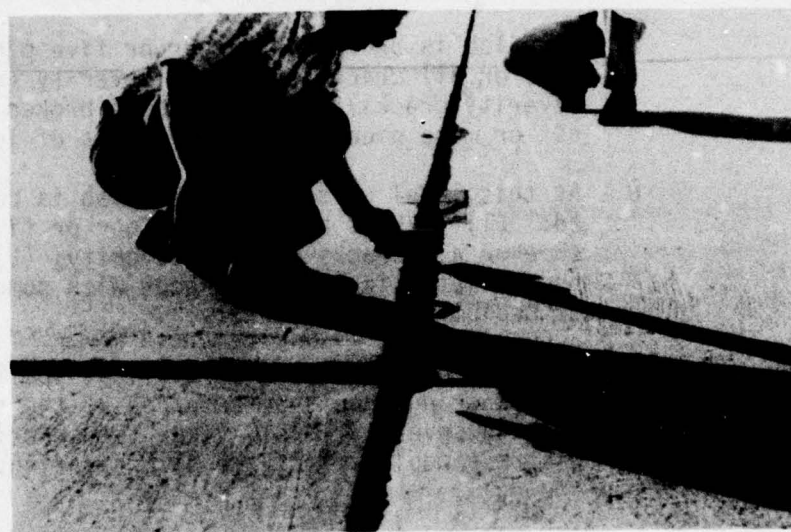
Figure 119. High Severity Settlement.

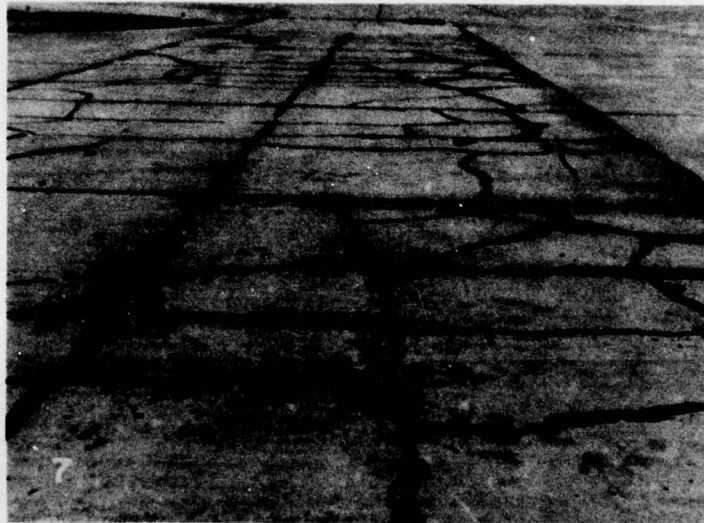
Figure 124. Shattered Slab.

Intersecting cracks are cracks that break the slab into four or more pieces due to overloading and/or inadequate support. The high severity level of this distress type, as defined below, is referred to as shattered slab. If all pieces or cracks are contained within a corner break, the distress is categorized as a severe corner break.

- L - Slab is broken into four or five pieces with some or all cracks of low severity. (Figures 120, 121)
- M - (1) Slab is broken into four or five pieces with some or all cracks of medium severity (no high severity cracks); or (2) slab is broken into six or more pieces with all cracks of low severity.
- H - At this level of severity the slab is called shattered: (1) slab is broken into four or five pieces with some or all cracks of high severity; (2) slab is broken into six or more pieces with some or all cracks of medium or high severity.

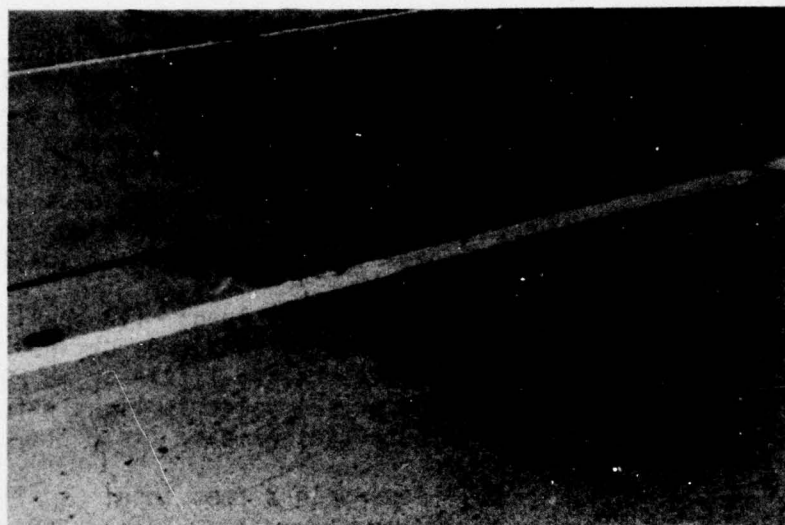
Figure 126. Shrinkage Cracks.

Name of Distress:	Shrinkage Cracks
Description:	Shrinkage cracks are hairline cracks that are usually only a few feet long and do not extend across the entire slab. They are formed during the setting and curing of the concrete and usually do not extend through the depth of the slab.
Severity Levels:	No degrees of severity are defined. It is sufficient to indicate that shrinkage cracks exist. (Figures 125, 126, 127)
How to Count:	If one or more shrinkage cracks exist on one particular slab, the slab is counted as one slab with shrinkage cracks.

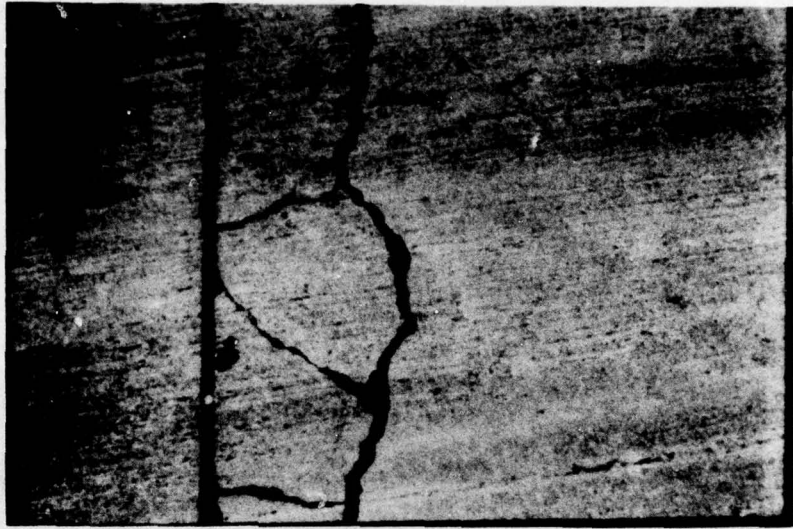
Figure 132. Medium Severity Joint Spall.

b. Spall less than 2 feet long: spall is broken into pieces or fragmented, with some of the pieces loose or absent, causing considerable FOD or tire damage potential. (Figures 131, 132)
